**QUIET CLEAN SHORT-HAUL EXPERIMENTAL ENGINE  
(QCSEE)**

**UNDER-THE-WING ENGINE COMPOSITE FAN BLADE**

**PRELIMINARY DESIGN TEST REPORT**

General Electric Company

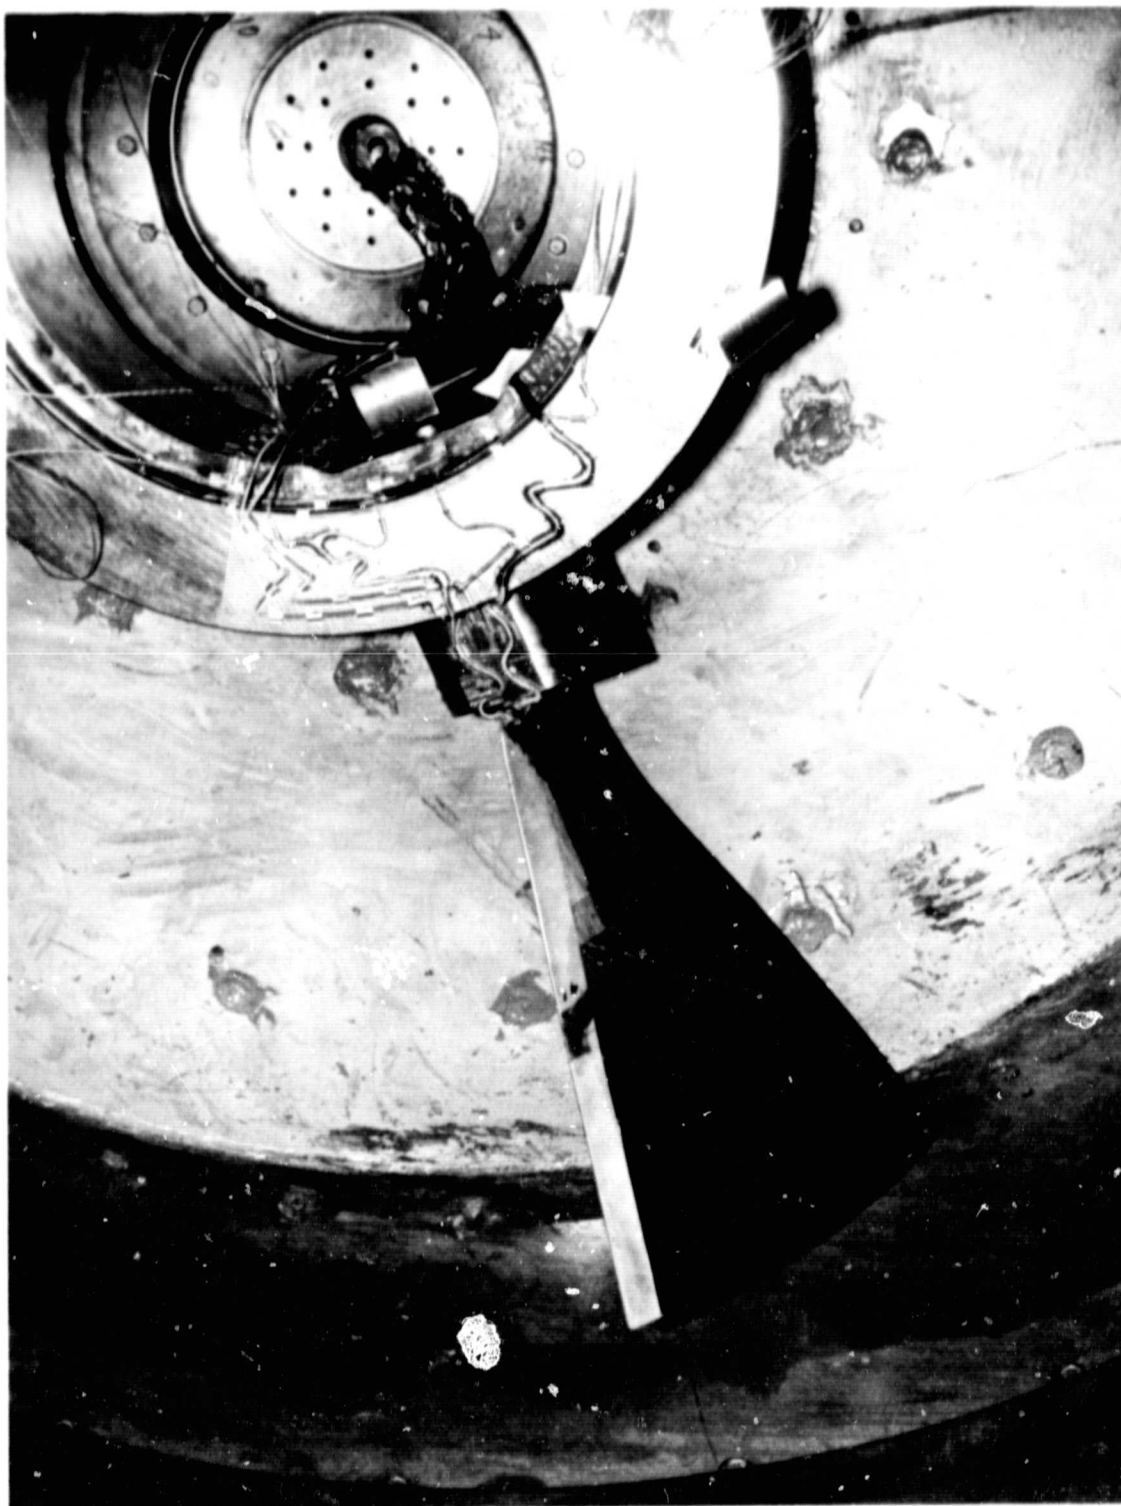
Figure 26. Whirrig Impact Facility.

In order to determine the impact capability of the UTW composite fan blades from the ingestion of 0.9 Kg (2 lb) birds, two whirligig impact tests were conducted. Blades S/N QP005 and QP011 were impact tested, one at a time in the whirligig facility shown in Figure 26.
